**Title:** Track 1 Assessments for the PBF-30, PBF-31 and PBF-32 Tanks

DECISION DOCUMENTATION PACKAGE  
COVER SHEET

Site description: PBF Reactor Area Abandoned Septic System

Site ID: PBF-30

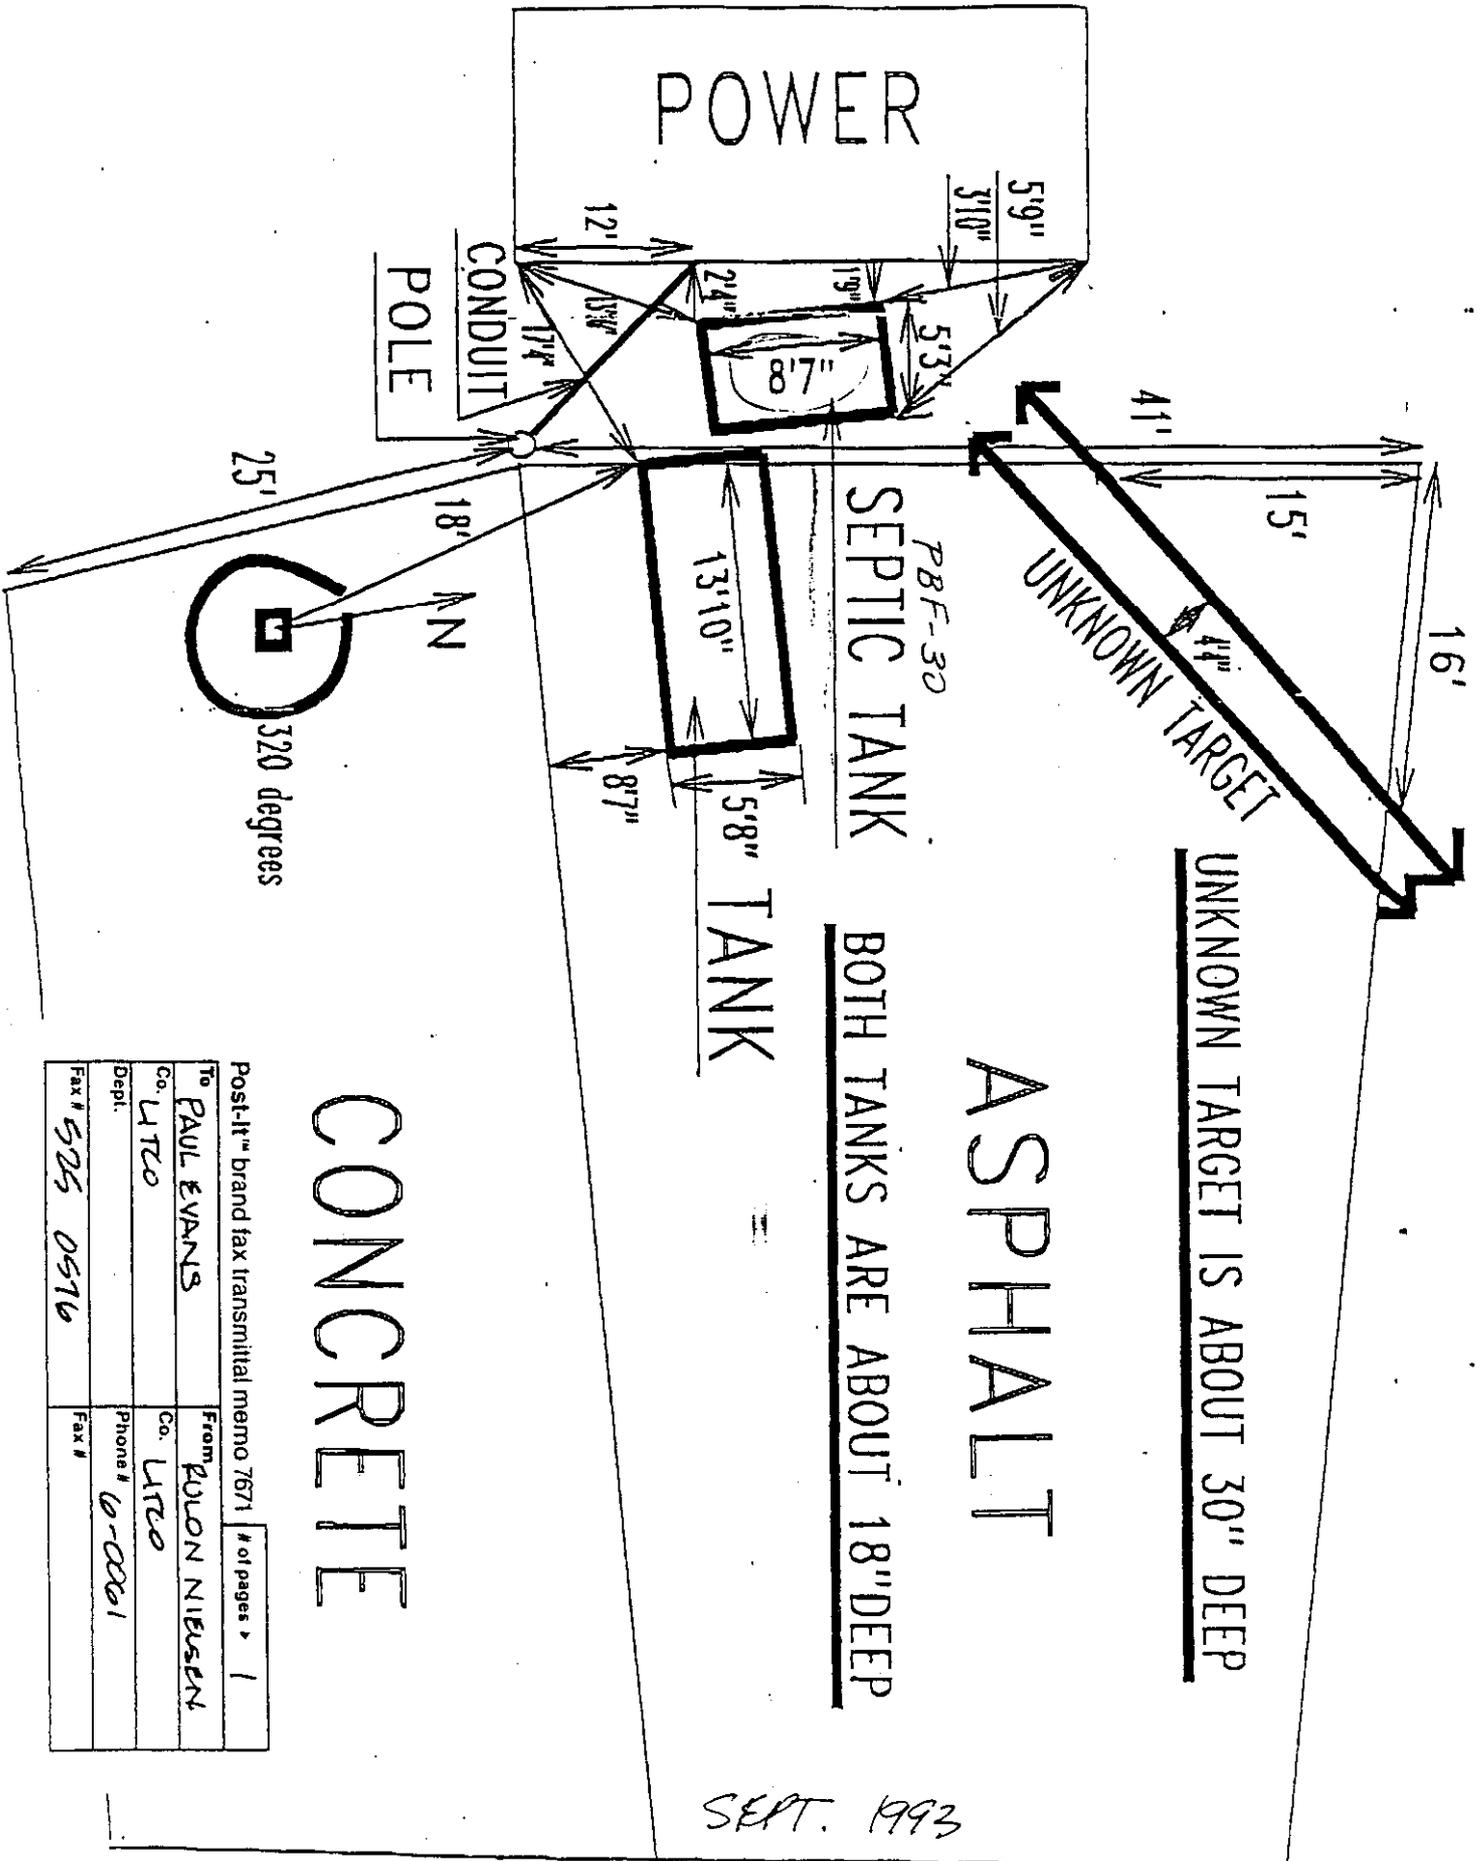
UNKNOWN TARGET IS ABOUT 30" DEEP
