IV. RETRIEVAL AND HOT CELL OPERATIONS

1. SINGLE BARREL EXCAVATIONS

1.1 Single Barrel No. 771-7285

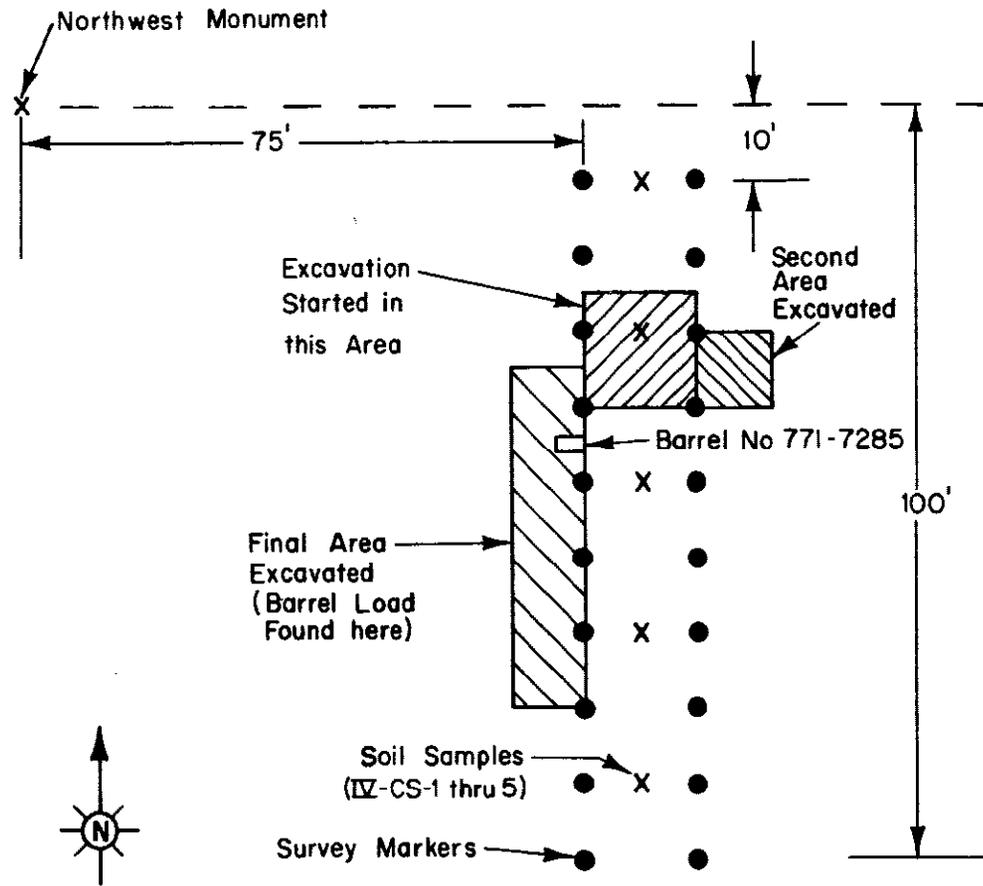
Figure 10 is a diagram of the excavation site. The location specified by the burial ground records was surveyed and marked as indicated in the figure. Soil samples were collected and analyzed to determine the concentration of Pu that could be expected prior to excavation operations. No significant contamination ($>1 \times 10^{-6}$ Ci Pu/g soil) was found.

Table IV is a summary of Pu analyses of the soil samples that were collected prior to the beginning of digging. The excavation began at the northern end of the surveyed area, proceeded south, and was continued by moving first to the east and then to the west until waste containers in the load containing Barrel No. 771-7285 were found.

Fig. 10 Pit 11 Excavation for special Barrel No. 771-7285.

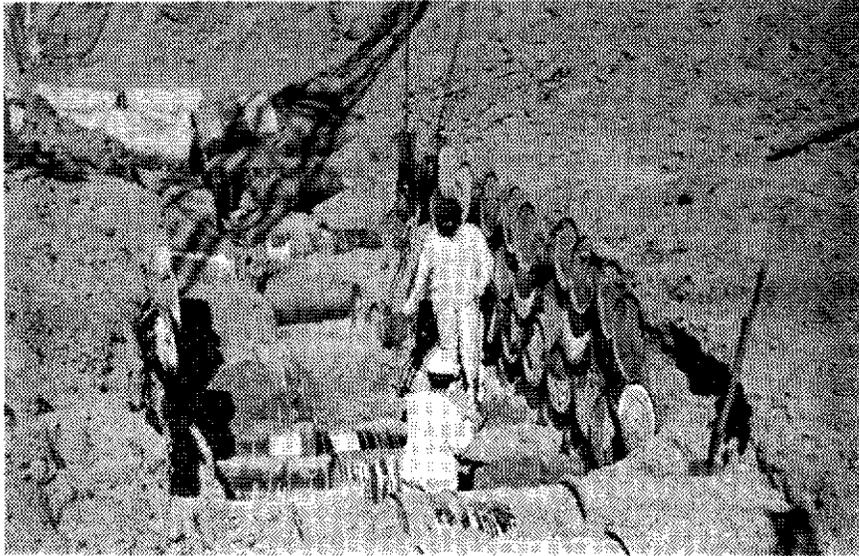
Figure 11 shows the excavation site just prior to finding Barrel No. 771-7285. Stacked barrels, such as found in this pit, presented minimal difficulties in retrieval operations. Excavation with a backhoe proved to be the best for the removal of the bulk of the dirt. However, hand-digging in the near vicinity of the barrels reduced the chances of rupturing barrels or hooking ring closures. A crane with a barrel chain-lifting device was used to remove the barrels, once they were uncovered.

Fig. 11 Excavation site for Barrel No. 771-7285.

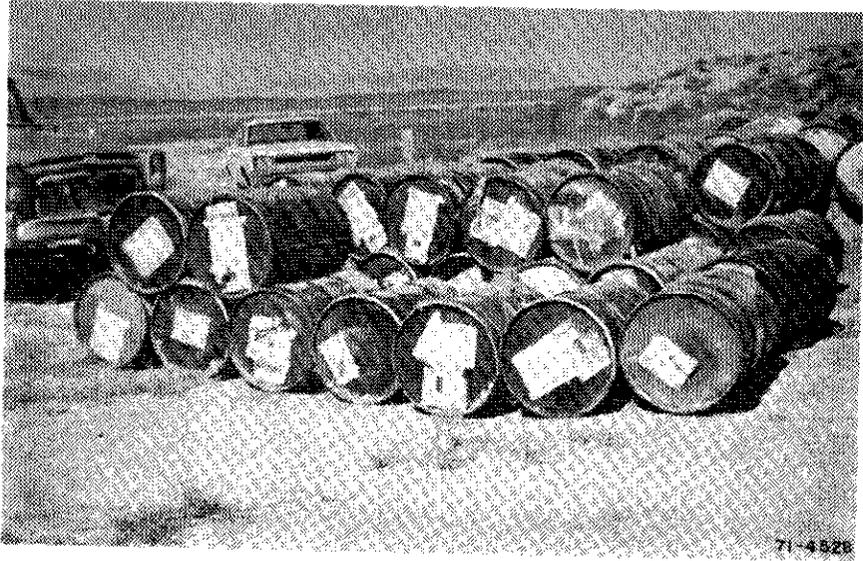
Identification of barrels was not difficult at this site, as 95% of the tags were intact. Figure 13 shows typical paper labels and metal tags on barrels from the first excavation site single barrels.

Fig. 13 General Barrel and Tag Condition (Pit 11).

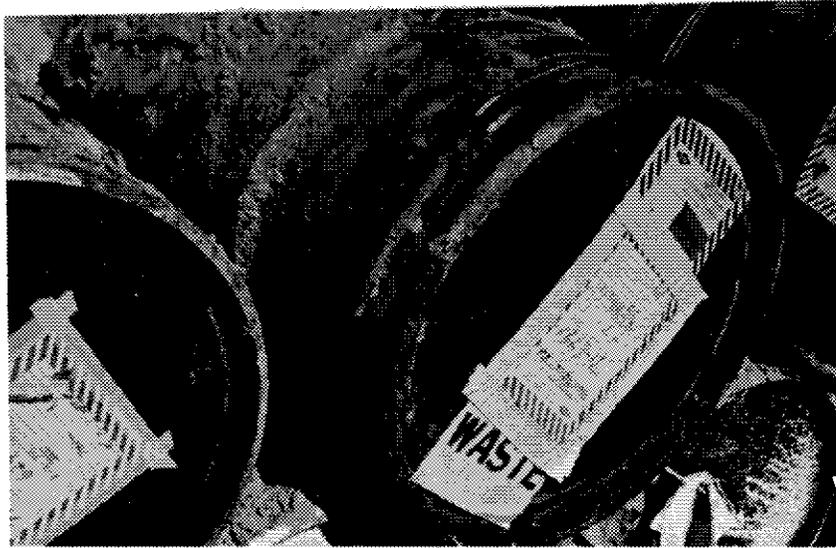
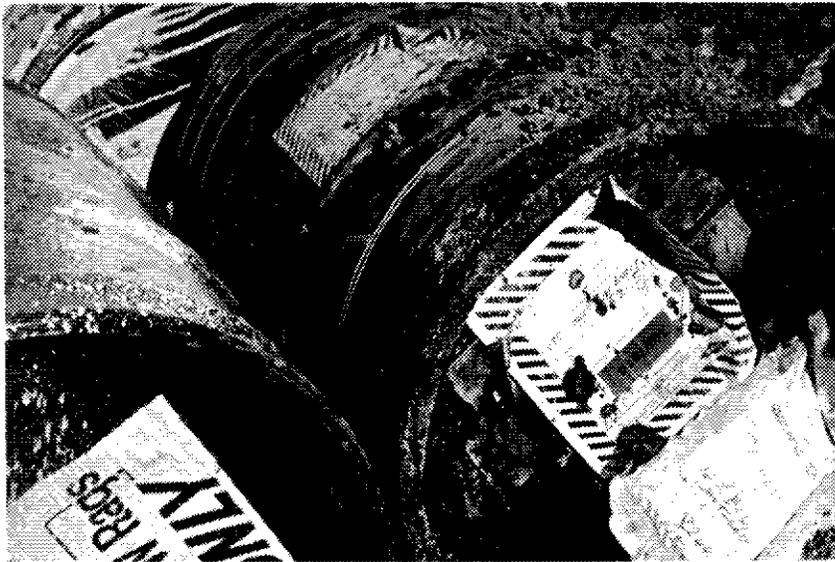
Nearly all the barrels which were removed from this excavation showed some localized corrosion. Figure 15 shows typical examples of ring closures which were corroded. The external corrosion was not sufficient to compromise the integrity of barrels examined in Pit 11.

Fig. 15 Typical barrel corrosion.
