**Site 011 Track 1 Decision Documentation**  
**Package, OU 10-08**

**DECISION DOCUMENTATION PACKAGE  
COVER SHEET**

<b>Site Description:</b>	Debris West of the Southern End of Highway 22		
<b>Site ID:</b>	011	<b>Operable Unit:</b>	10-08
<b>Waste Area Group:</b>	10

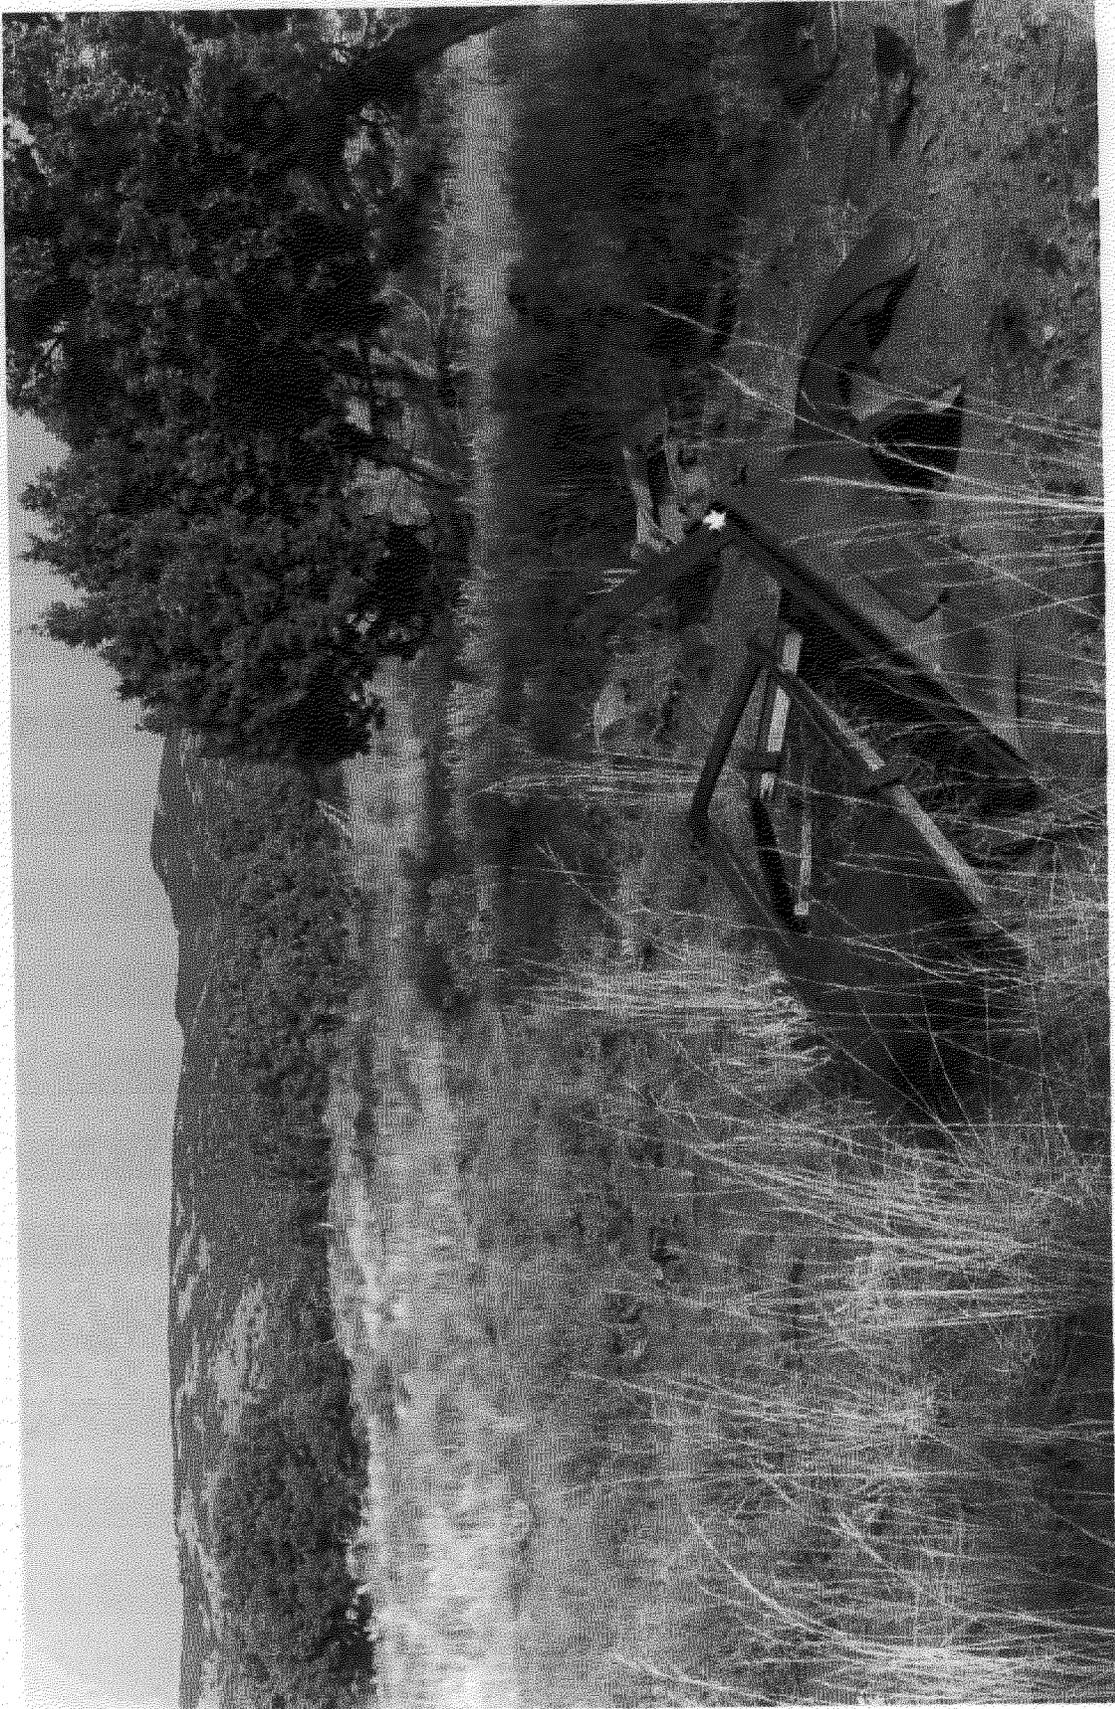
Site: 011, Debris West of the Southern End of Highway 22  
(PN99-0456-2-16)

INEEL WAG 10 and Cultural Resources investigated the site. Site investigations revealed two small domestic debris piles containing scattered early-model automobile body panels, (no engine is present), empty rusted cans, and weathered wood. There is no evidence to indicate that any of the debris found at the site was industrial in nature or related to INEEL operations. Cultural Resources personnel noted that the artifacts appear to be more that fifty years old (automobile circa. 1930's). Some artifacts are from mining-related activities.

There is no visual evidence of hazardous constituents, nor evidence that waste has recently been disposed of at this site. There is no evidence of disturbed vegetation, or stained or discolored soil. The ground surface shows well-established native grasses and sagebrush. The description of the site conditions is based on recent site investigations and INEEL Cultural Resource research; no field screening or sample data exist for this site.

It is recommended that this newly identified site be classified as No Further Action. Field investigations, interviews with personnel having historical knowledge of the area, and photographs indicate it is highly unlikely that hazardous or radioactive materials were generated or disposed of at this site. It is located in a remote, abandoned area with no viable pathways or receptors. There is nothing present at this site that would indicate evidence of contaminant migration, or historical or threatened release of hazardous substances, pollutants or contaminants. There is no evidence that the debris is related to INEEL operations. This site is similar to several other small domestic trash piles across the INEEL that were related to either homesteads or stage crossings containing domestic, agricultural, or mining waste that does not pose a potential risk to human health or the environment.
