**DECISION DOCUMENTATION PACKAGE
COVER SHEET**

**TRACK 1 SITES:
GUIDANCE FOR ASSESSING
LOW PROBABILITY HAZARD SITES
AT THE INEEL**

Site Description:	Experimental Test Drum in EOCR-01 Leach Pond		
Site ID:	033	Operable Unit:	10-08
Waste Area Group:	10

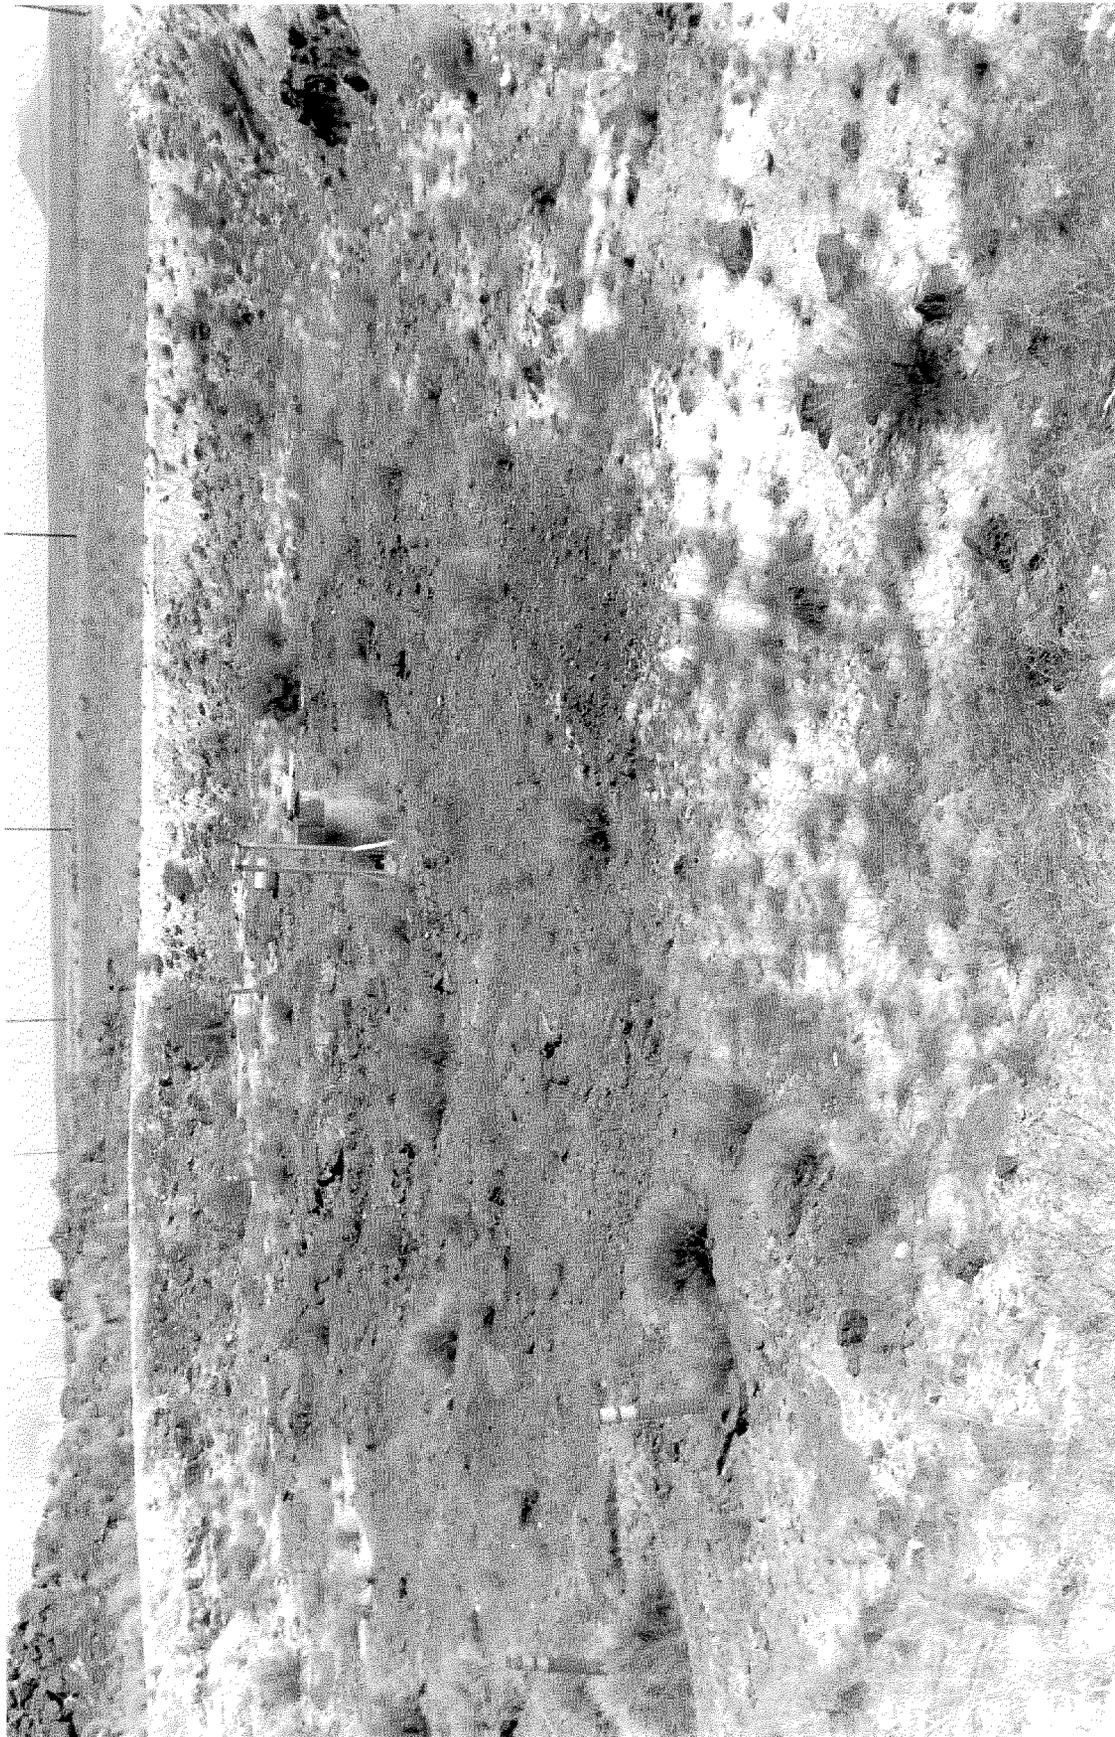
Site: 033 Experimental Test Drum in EOCR Leach Pond
(PN99-0494-1-1)

The drum covers an area approximately 3 feet in diameter and the debris and ash in the bottom appear to be a few inches deep. The drum contains ashes, thermocouples, graduated cylinders, beakers, stainless steel blocks, pipettes, crucibles, and other items used during the experiments.

It is recommended that this newly identified site be sampled for nitroaromatics and lead for risk characterization and disposal purposes. Although the test drum, apparatus, and debris are isolated in the EOCR-01 leach pond, and are unlikely to pose an unacceptable risk to human health or the environment, the actual calculated risks and potential disposal restrictions are unknown.

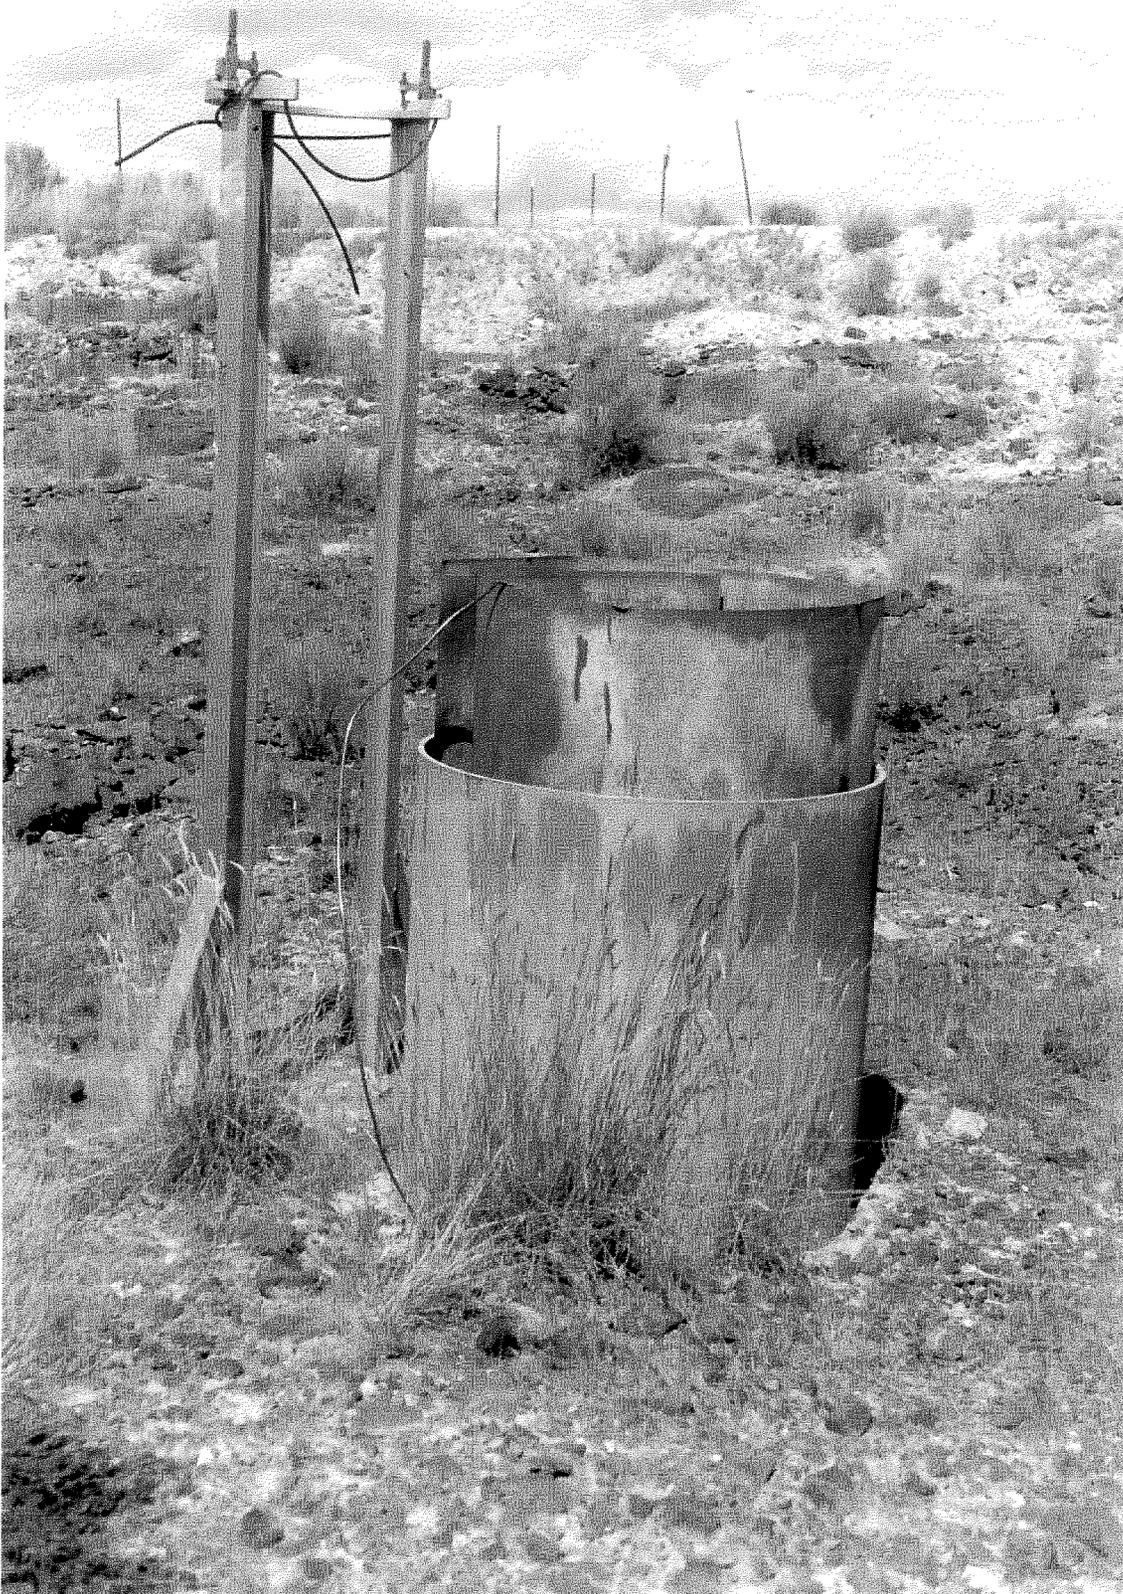
Site: 033 Experimental Test Drum in EOGR Leach Pond
(PN99-0494-1-3)

There is no evidence of migration at Site 033. Site investigations reveal no visual evidence of hazardous constituents, disturbed, stained or discolored soil areas, or odors outside the test drum. The test apparatus and debris have been exposed to extreme weather conditions for almost 20 years and appear to be contained within the test drum and cylinder.

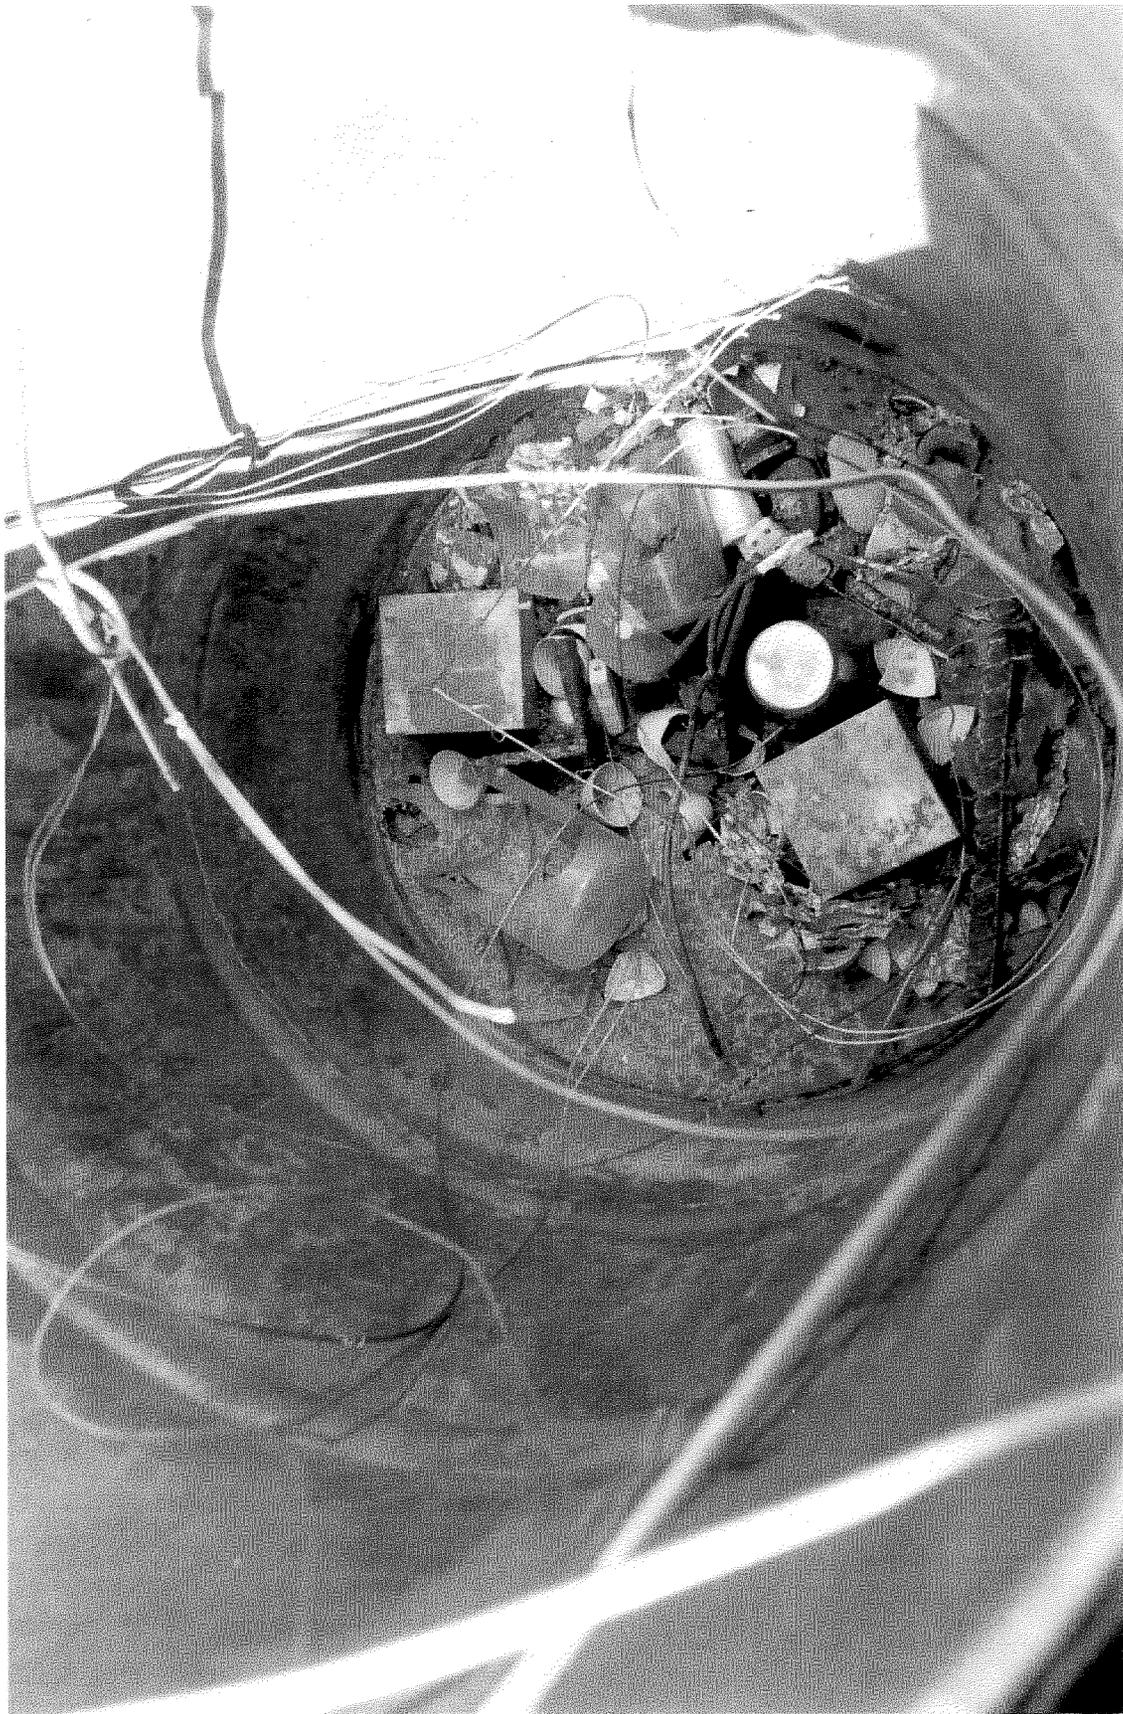
Site: 033 Experimental Test Drum in EOGR Leach Pond
(PN99-0494-1-2)

There is no expected pattern of potential contamination outside the test drum, but ash and debris inside could be contaminated with lead and nitroaromatics. Based on historical research of the EOCR Leach Pond and a radiological survey, there is no reason to suspect radioactive constituents are present at this site. The drum covers an area approximately 3 feet in diameter and the debris and ash in the bottom appear to be a few inches deep.
