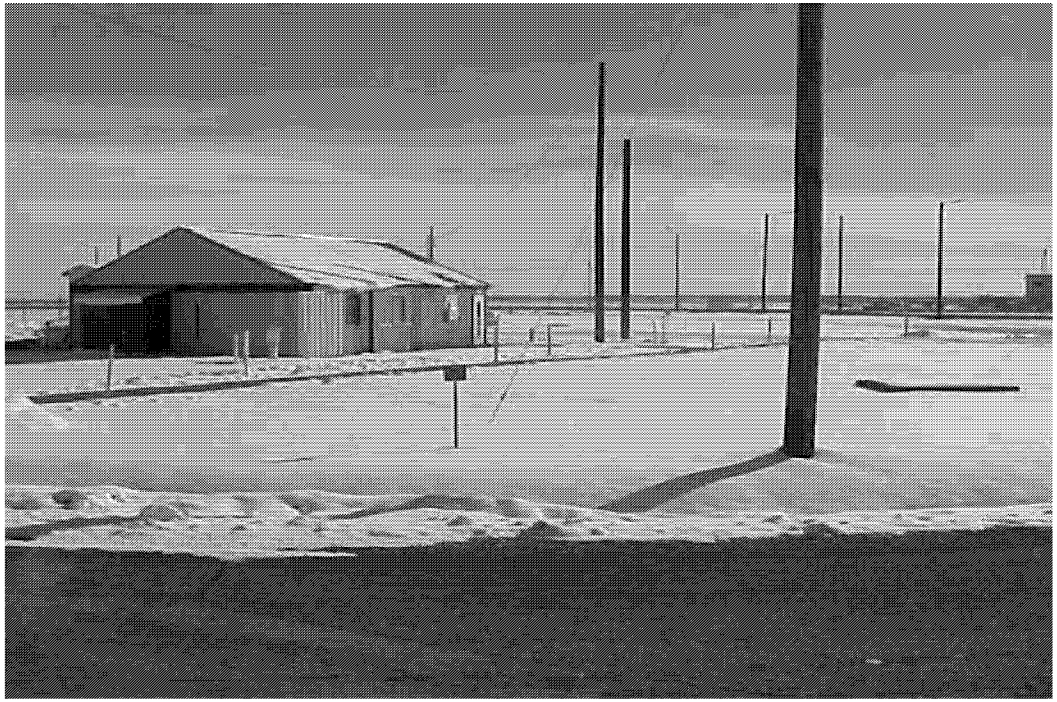
CPP-48

French Drain South of CPP-633
Depth: 12 ft bgs or deeper
Area: 50 ft^2
Volume: 600 ft^3

Note: The orange EAC sign is incorrectly placed. The sign belongs directly east of its present location, approximately where the person is standing.

Criteria	Data
Environmental Risk	This site has no constituents with concentrations greater than RGs, it is also not a significant contributor to Group 3 contamination.
Infrastructure	Easily accessible. 3—infrastructure (Dry well; Well MW-5 near-by; 1 – Condensate Waste line [grout filled]).
Integration	Intermediatte traffic area.
Future Use	No clear identified future use, no anticipated D&D&D through 2012.
Waste Management	"Minimal" debris generation (pipes, paving concrete, etc.).
Worker Complexity	Low to moderate mixed contamination with little to no physical hazards and restrictions, no labor or hand work anticipated.
