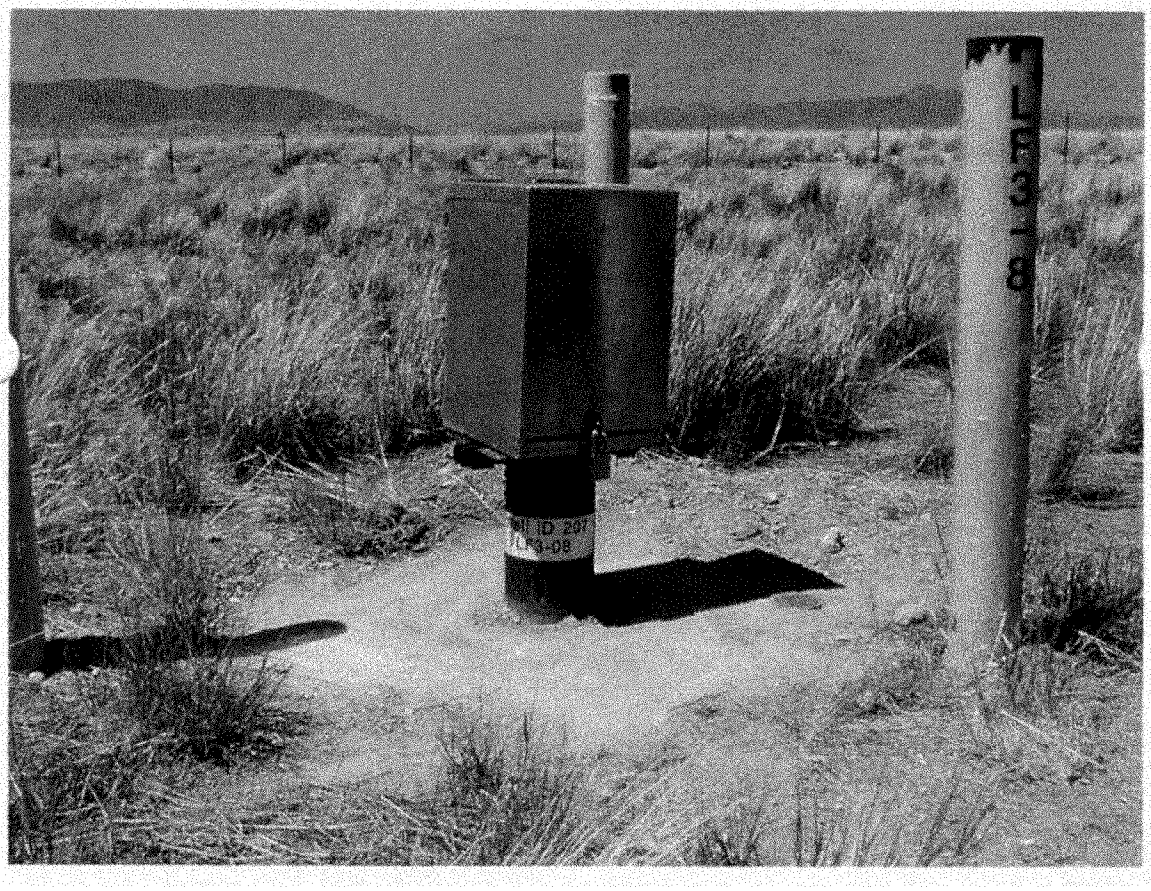
File Name:CFA\207 may 30 01 open box.jpg

Describe the general condition of the well: good steel 6" casing

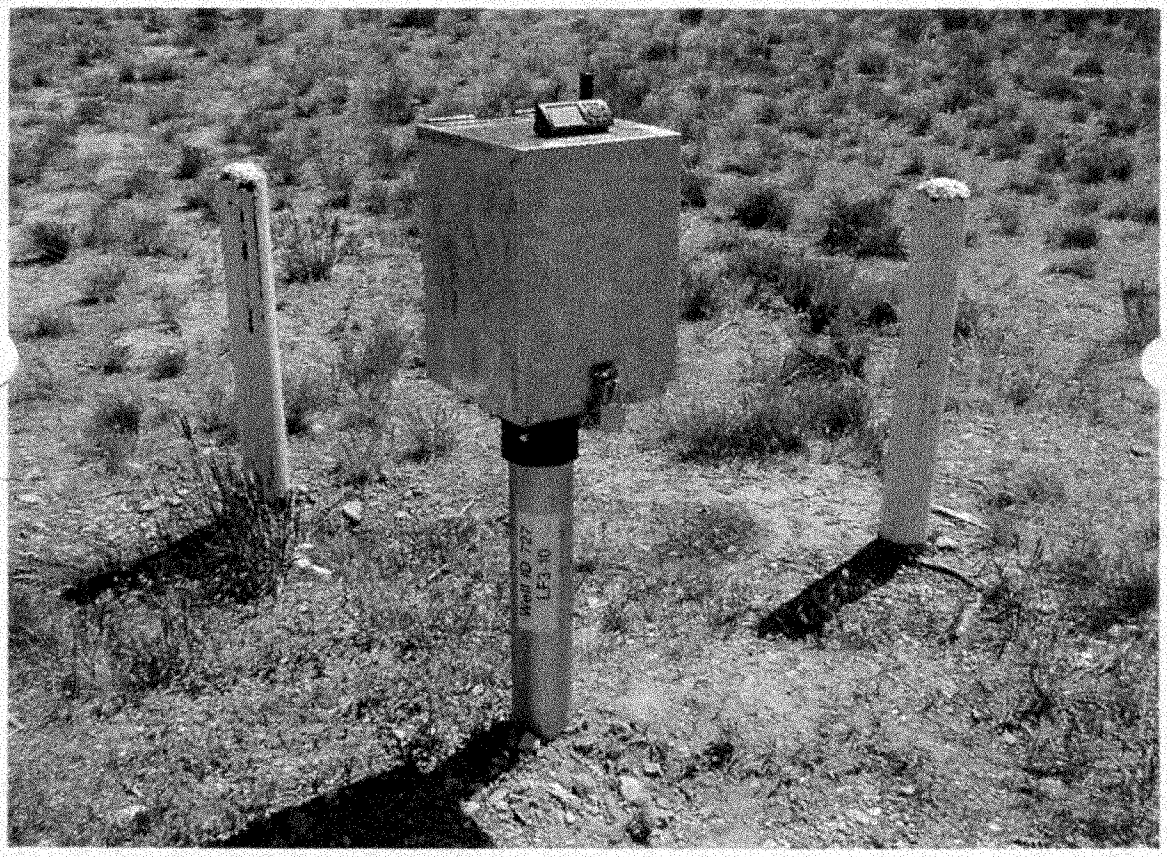
File Name:CFA\727 may 30 01 open box.jpg

Describe the general condition of the well well need protective surface casing
well needs surface pad - Brass cap
well needs Resurveying
