Appendix J

Drilling/Sampling Activity Radiological Survey Reports/Radiological Control Daily Log Sheets

RADIOLOGICAL SURVEY REPORT

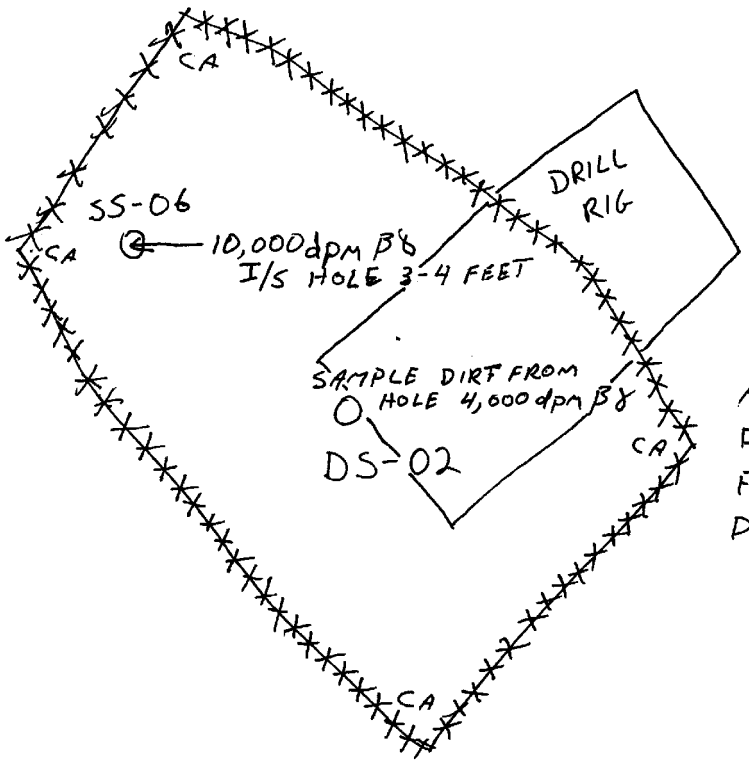
BLDG.: NORTH V TANKS	☐ ROUTINE **JOB DESCRIPTION**
AREA/ROOM: NORTH V TANKS	☒ NON ROUTINE (SPECIFY) ☐ FOLLOW UP
RWP #: 31003018	COMMENTS: DIRT WAS FILLED BACK IN HOLE
LOG #: 3	SS-06 EXECPT WHAT COULDNOT FIT IN HOLE
DATE: 7-2-03	THE REST OF THE DIRT WAS PUT IN BAGS AND
TIME: 1630	TAPED CLOSED

AUGERS AND SMALL DRILL RIG RELEASED FROM CA WITH NO DETECTABLE READING

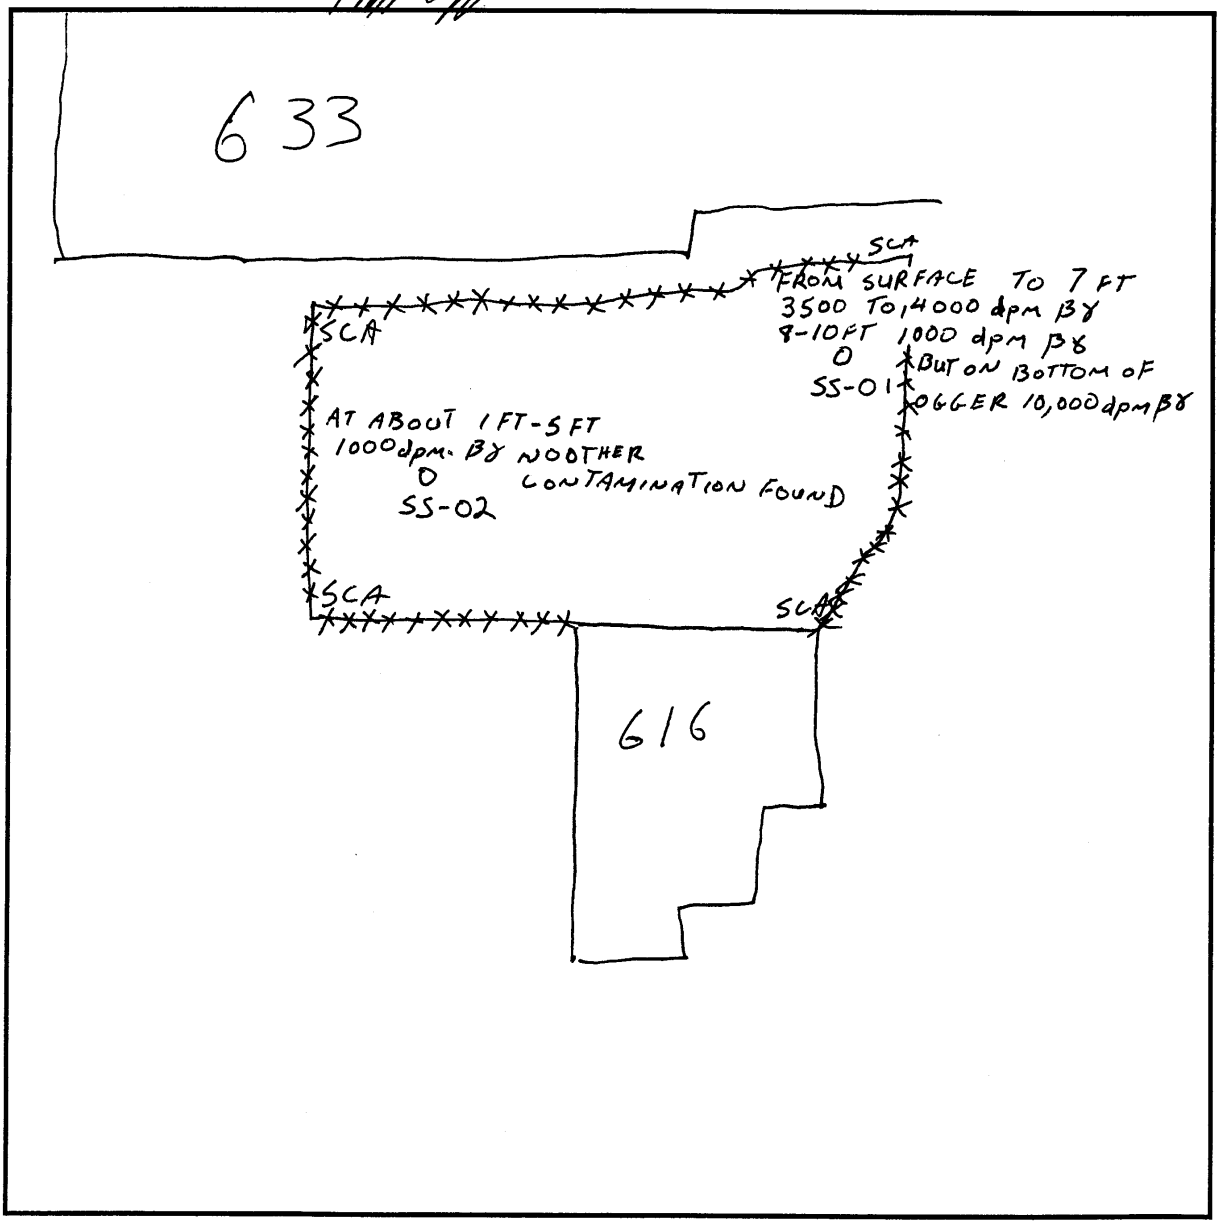
BLDG.: NORTH OF V TANKS	☐ ROUTINE **JOB DESCRIPTION**
AREA/ROOM: NORTH OF V TANKS	☒ NON ROUTINE (SPECIFY) ☐ FOLLOW UP
RWP #: 31003018-00	COMMENTS: ALL SAMPLES HAD TO BE TAKEN TO A LOWER BACKGROUND AREA TO GET GOOD READINGS AND ALL READINGS WERE DIRECT FRISK
LOG #: 7	
DATE: 7/7/03	
TIME: 1700

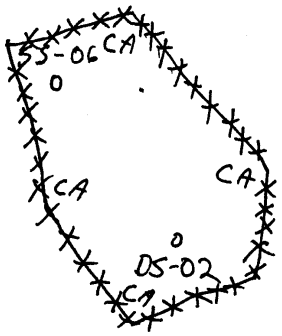
633

BLDG.: NORTH V TANKS	☐ ROUTINE **JOB DESCRIPTION**
AREA/ROOM: NORTH V TANKS	☒ NON ROUTINE (SPECIFY) ☐ FOLLOW UP
RWP #: 31003018-00	COMMENTS: AREA WAS SECURED WITH NO EXTRA SPREAD OF SOIL CONTAMINATION. SURFACE WAS COVERED WITH PLASTIC
LOG #: 11	
DATE: 7-9-03	
TIME: 1655

SURFACE CONTAMINATION
LEVELS FROM 1000 dpm TO 5000 dpm βγ

9.	1600	G. Lusk	TAN 616	12	N/A	T.T.Mukherjee	Reported the Capture and disposal of one Rat. Outside of Evap Tent. Shift Supervisor notified by Jim Clayton.
10	1630	S. Lewis	TAN 602	2	2A 800146	E.E. Brown	Direct frisk on bagged ACM. All <1000dpm.
11	1655	L. Lopez	North V tanks	2	2A 800031 2A800659	W. P. King	Survey of soil contamination found from 1000 – 5000 dpm $\beta\gamma$ all covered with plastic
