NEW SITE IDENTIFICATION (NSI)

Part A – NEW SITE IDENTIFICATION INFORMATION (To be completed by the Task Lead for New Site)	
1. **Site Title:** 1½" PLA-2069C Leak West of CPP-750	**Site Code:** CPP-124 **NSI Evaluation Initiation Date:** 4/20/2005
2. **Task Lead For New Site:** Wendell Jolley	Phone: 526-5990
3. **NSI Coordinator:** Nielsen Burch	Phone: 526-5676
4. **Initiator or Initial Observer:** Richard Willson	Phone: 526-9641

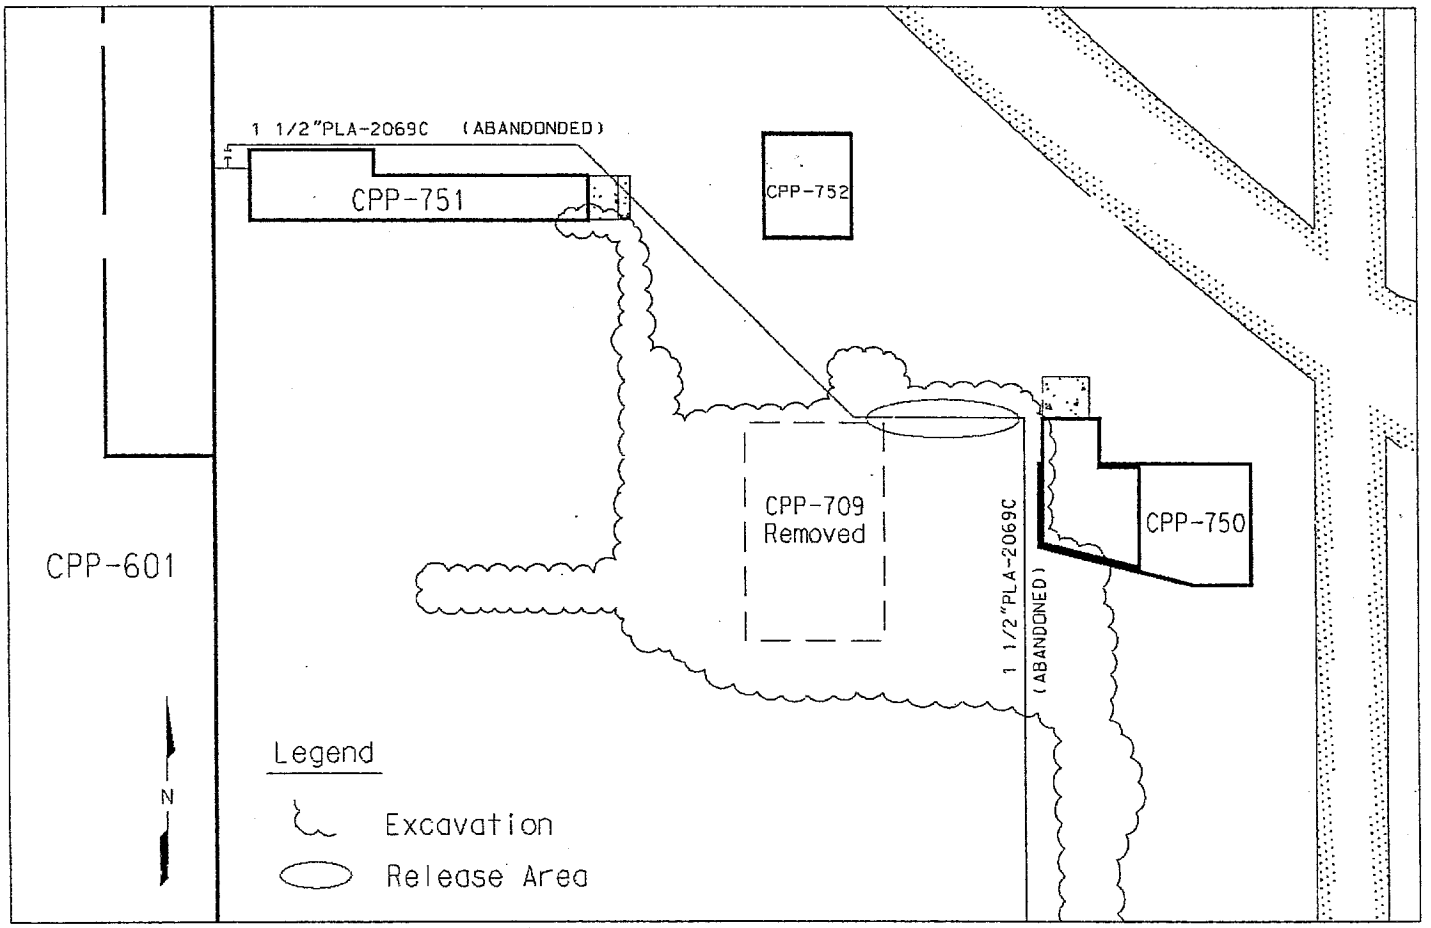
During a transfer of PEWE overhead condensate (also called process condensate) from CPP-604/605 to the service waste system three small leaks in the underground transfer line (1 ½" PLA-2069C) west of CPP-750 were observed. The area where the leaks were observed was in an excavated area for the new service waste upgrade. When the leaks were observed, the transfer was terminated, and the pump was tagged out. The release is documented in the Plant Operation Summary for 12/07/1987 log number 24 (Appendix A). Also contained on that summary are hand written notes that indicate that the "possible" contaminants "may be hot" (radioactive), "acidic, and" contain "metals". Part of those notes say; "Paul Owens – Production – is working on it. Gave him 2 sample jars. He will have pH run on (soil samples) a sample". Information concerning sample results, volume of liquid released, volume of soil contaminated, or soil removed are not available. See Figure 1 for a location map.

Figure 1. Drawing showing the location of the CPP-124 release.
