U.S. Department of Energy
Idaho Operations Office

Final Removal Action Report for the CPP-603A Basin Facility

Idaho Cleanup Project

DOE/ID-11306
Revision 0

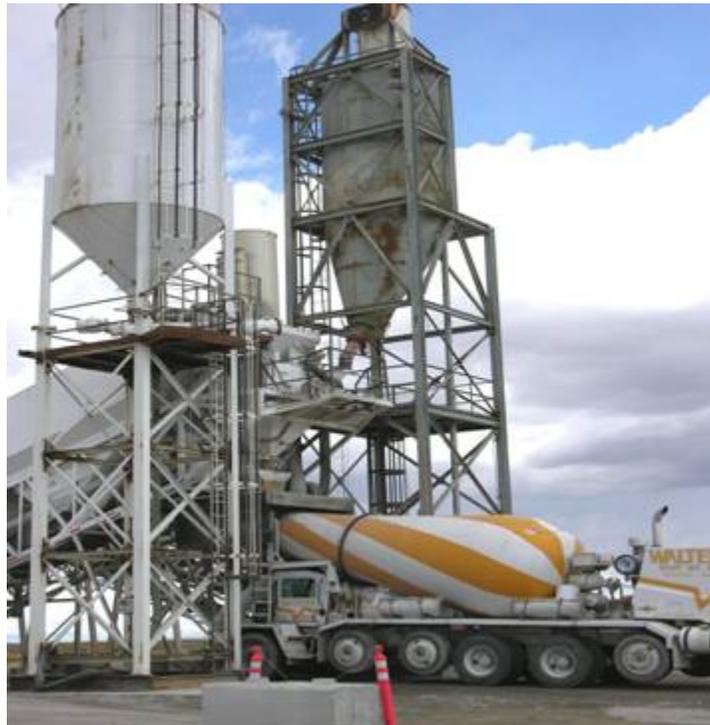
Figure 1. Grout Batch Plant.

To support the CPP-603A basin dewatering and grout/CLSM placement as well as other projects at INTEC, including Tank Farm Closure, a subcontract was executed to establish a cement batch plant east of INTEC outside of the security fence. The batch plant was capable of producing custom grout mixes at a rate to support grout/CLSM placement at CPP-603A. Grout/CLSM was delivered from the batch plant to CPP-603A in cement trucks with a capacity of 10 yd³.

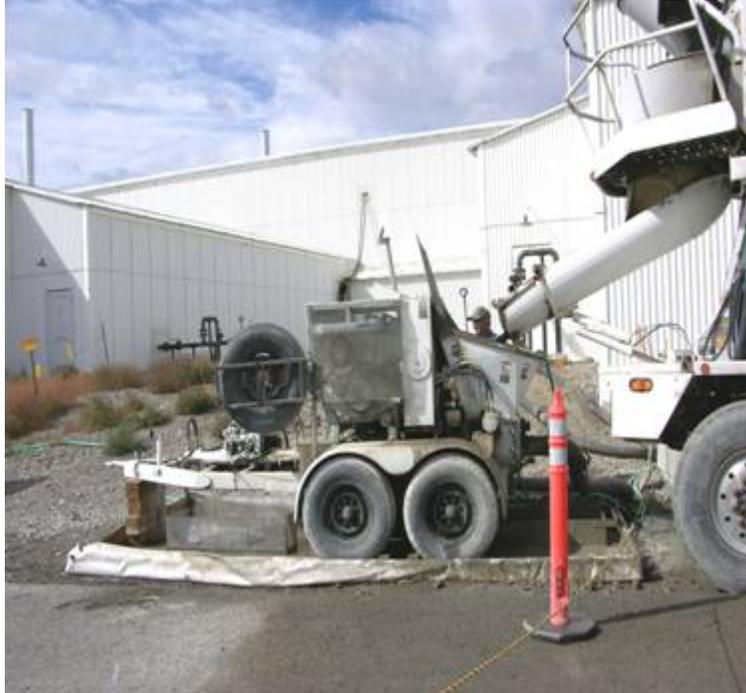
Figure 2. Grout/CLSM Pump.

Grout/CLSM was pumped into the CPP-603 basin system as described in Section 2.4 of the Removal Action Work Plan. Two grout/CLSM mixture recipes were utilized in the basin system. Mix 1 was specifically designed to be very flowable and self-leveling. Mix 1 was used for the initial pours to encapsulate any residual sludge that may have remained in the basins and debris on the bottom of the basins. However, some of the pipes and hoses left in the basins, as well as debris piles, were configured in such a way that could trap water in the pipe or hose sections. As a result, it is possible that small volumes of water were not completely displaced by the grout/CLSM and could be encountered during future remediation. The water is fully encapsulated now, but future workers should be aware that it may exist. Mix 2 contained a large fraction of sand and smaller amounts of fly ash and cement. Due to the composition of materials in Mix 2, it was less flowable. Because it contained less fly ash, Mix 2 tended not to increase the water pH as drastically as Mix 1. Mix 2 was used to fill the majority of the void space in the basin system.

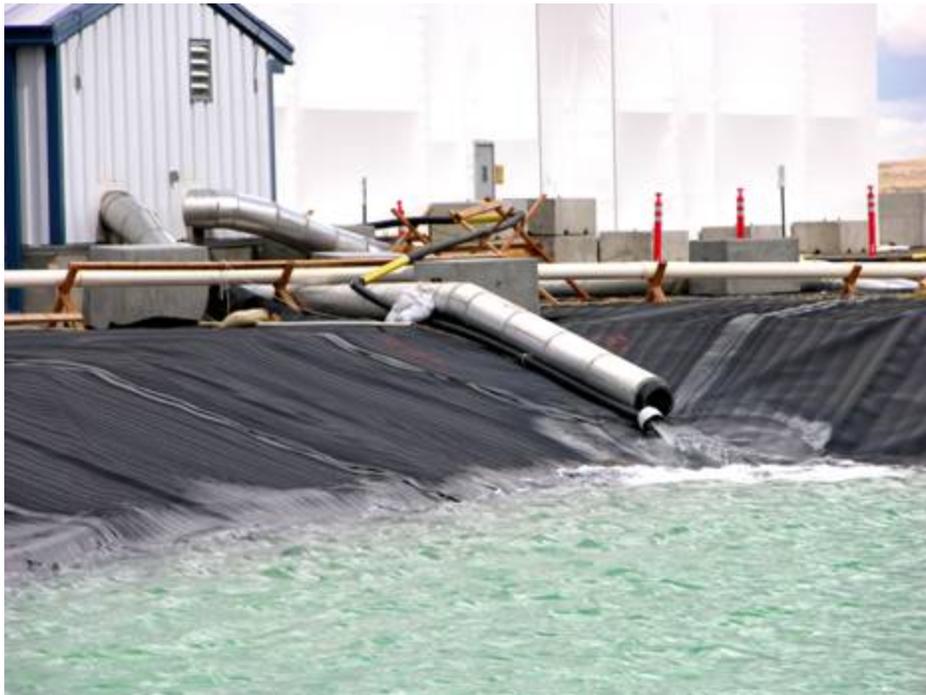
Figure 3. Basin Water Discharge to ICDF Evaporation Pond.

On August 22, 2006, the first basin water was pumped to ICDF. The first grout/CLSM was placed in the North Basin on August 23, 2006. Basin water pumping continued on a 5-day/week, 10-hour/day schedule during routine operation. The last of the basin water was pumped to the ICDF evaporation ponds on November 3, 2006. Basin water was pumped from below the water surface in the overflow pit through carbon steel pipe with duplex filters and totalizing flow meter in line. Outside of CPP-603, the transfer piping transitioned to 3-inch high density polyethylene (HDPE) through the remaining route to the ICDF evaporation ponds as described in Section 2.4.4, *Water Removal System Design* in the Removal Action Work Plan.

A total volume of 1,191,842 gal of basin water was pumped from CPP-603A to the ICDF evaporation ponds. The discrepancy between the volume of water actually pumped and the 1,519,000 gal estimated in the Removal Action Work Plan is due to: 1) the estimates in the Removal Action Work Plan did not exclude the volume already filled by beams, columns, and debris within the basin system, and 2) some unmeasured volume of basin water was incorporated into the grout/CLSM mixture as it was placed into the basin system and solidified.

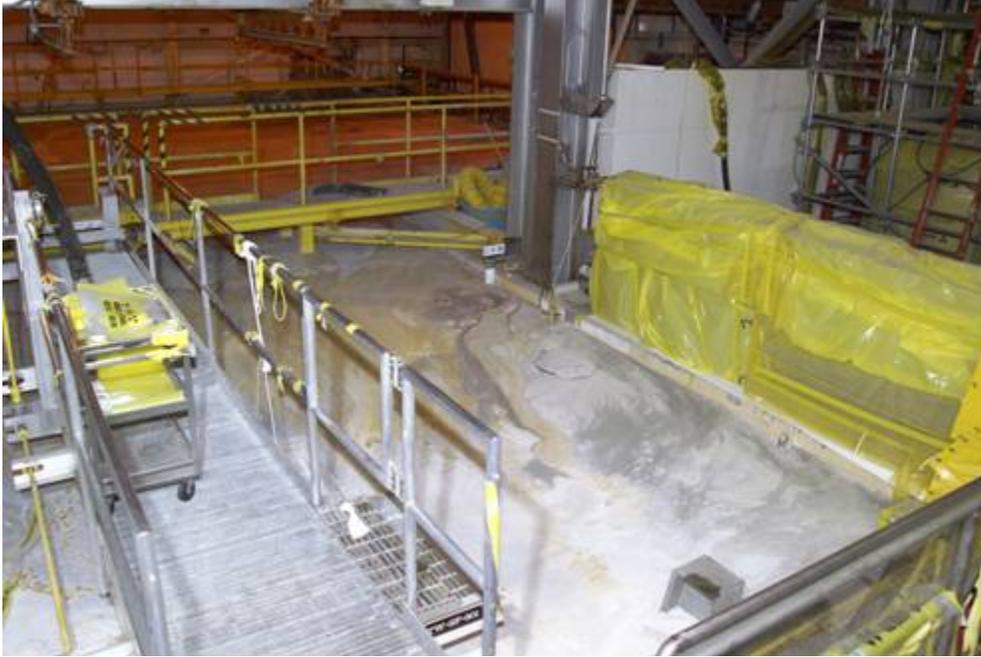
Figure 4. Grouted South Unloading Pit.

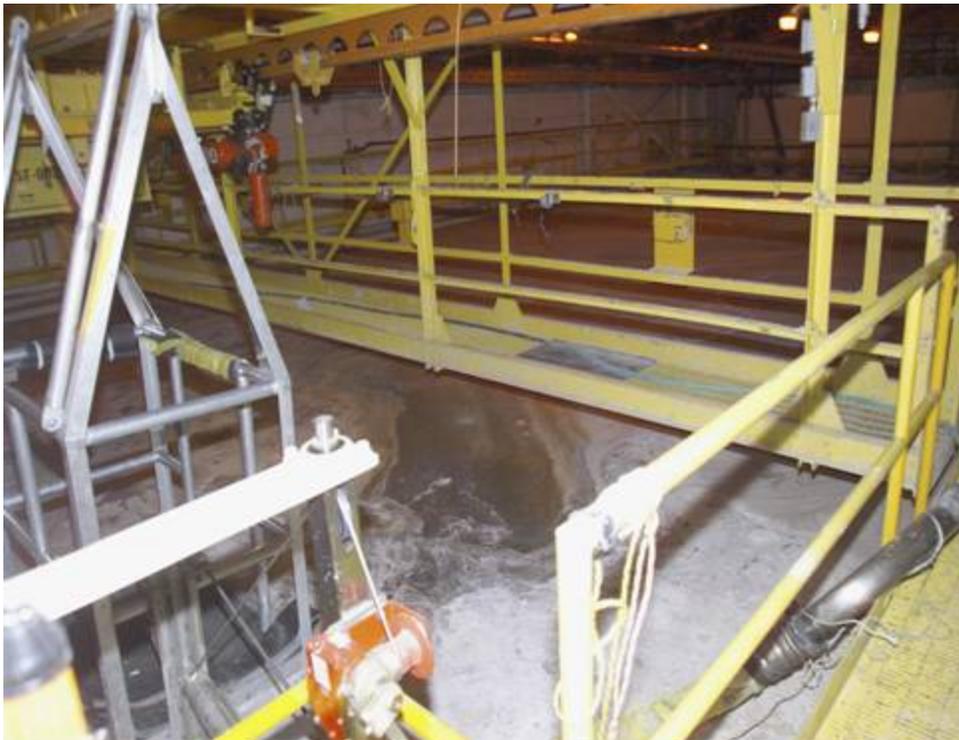
Figure 5. Grouted South Basin.

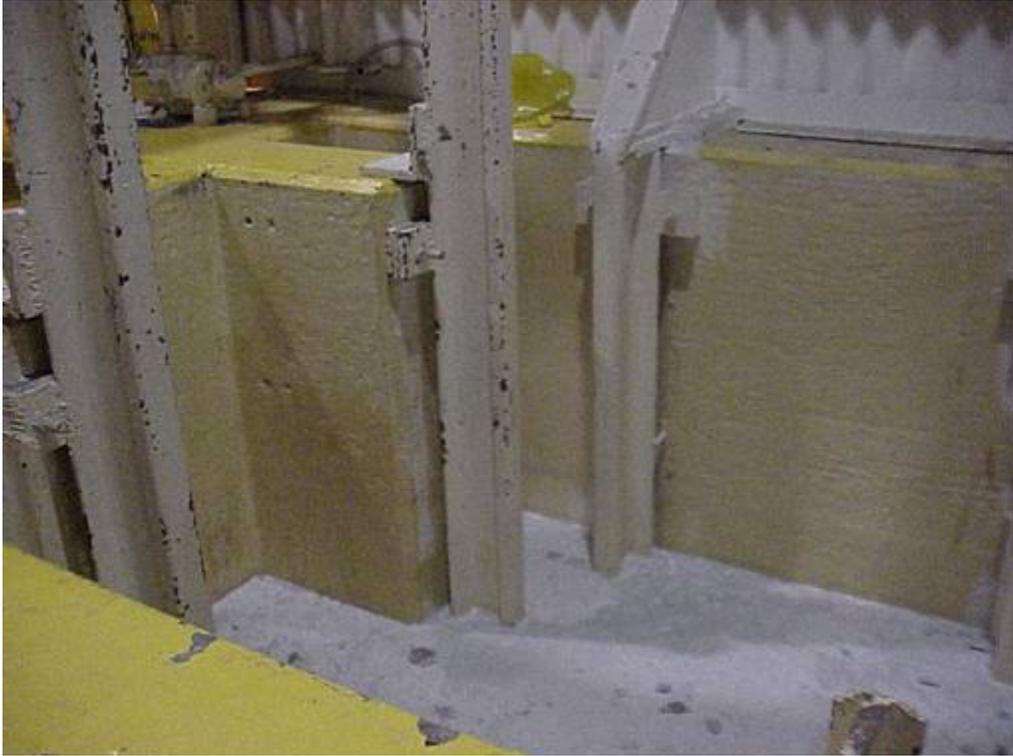
Figure 6. Grouted North Unloading Pit.
